CALIFORNIA DIVISION OF MINES AND GEOLOGY

FAULT EVALUATION REPORT FER-120

SUPPLEMENT NO. 1

San Andreas fault, northern San Mateo County area.

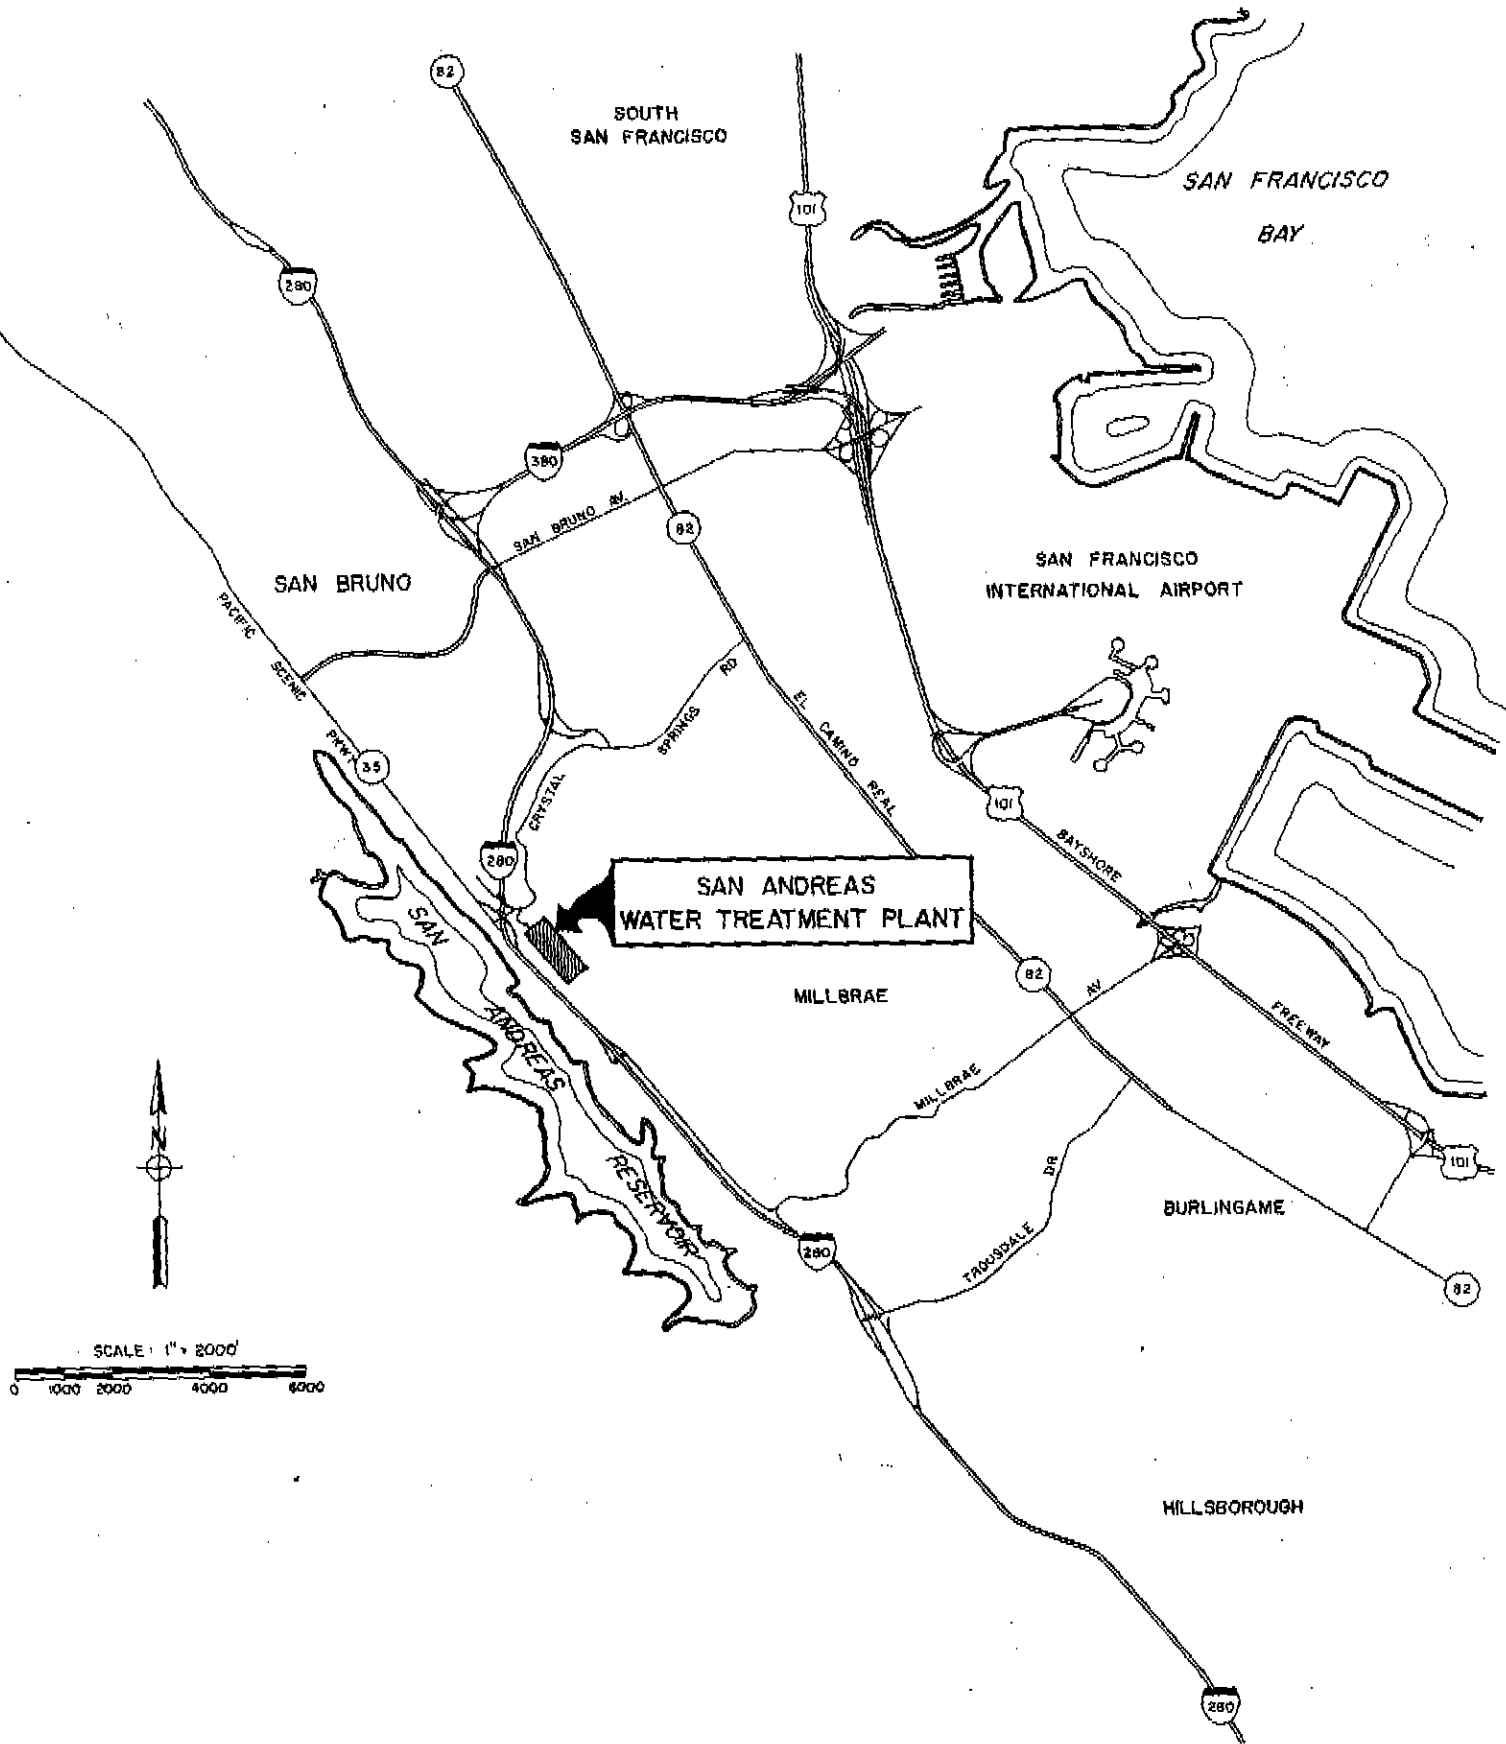
After the release of the Preliminary Review Maps by the California Division of Mines and Geology on 7/1/81, a geologic map of the Montara Mountain quadrangle was released by the U.S.G.S. (Pampeyan, 1981a). The location of the San Andreas fault shown by Pampeyan differs substantially from that shown on the preliminary review map in three places (see Fig. 1). At the northern end of San Andreas Lake,

Pampeyan depicts the active fault slightly to the west of that depicted by CDMG. Between San Andreas Lake and Lower Crystal Springs Reservoir, Pampeyan also depicts the fault slightly west of that shown by CDMG. He also cites the location of a pipeline ruptured by fault movement in 1906 near the eastern margin of the quadrangle (the third location).

Near the northern margin of the quadrangle, Pampeyan (1981a) shows two branch faults and two air photo lineaments, which he cites in his letter (1981b) as relatively young (see Fig. 1). He reports that the easternmost of these faults (Fault A) cuts Merced Formation and that <sup>a</sup><sub>A</sub> sag pond was visible along the fault on 1946 air photos. He shows the second fault (Fault B) as entirely in Franciscan material. He reports that two possible sag ponds were visible adjacent to the lineaments on the 1946 air photos.

Hall has forwarded a copy of a detailed, annotated map of the San Andreas fault between San Andreas Lake and Lower Crystal Springs Reservoir (Hall, 1981). According to Hall, the San Andreas fault has been identified in trenches at several locations (see Fig. 1). He also has verified locations of the 1906 rupture. Hall (1981) and Pampeyan (1981) generally agree on the location of the most recently active faults, differing slightly in detail. Both Hall and Pampeyan commented that several of the features depicted on Figure 3B in FER-120 between the lake and the reservoir follow a pipeline and are artificial.

USDA (1941) photos # 29-31 were re-examined for this supplemental report. The sag pond reported by Pampeyan (1981a; 1981b) along fault A (Fig. 1) was indeed present. Several other sag ponds were also present a few thousand feet to the north in the San Francisco South quadrangle. The latter ponds are fairly clearly due to

landsliding or lateral spreading. The pond along fault A was observed during the preparation of FER-120, and was also interpreted to be the result of lateral spreading of the ridge top. Vague tonals were observed along faults A and B. The stream north of fault B appears broadly deflected. It is possible that this deflection may have been "inherited" from the main trace which lies along about 350 feet to the west.

It appears that recent movement has occurred along fault A, although it is not certain whether this movement is the result of tectonic stresses or gravity. Equivocal evidence exists to support recent movement along fault B.

As a result of this re-evaluation, the following changes to the SSZ map appear appropriate (see Fig. 2):

1. Add a fault beneath Lower Crystal Springs Reservoir as shown on Fig. 2.
2. In the area between the reservoir and the lake, show the faults mapped by Hall (1981) and delete those shown on the preliminary map.

3. Add the fault shown by Pampeyan (1981) beneath San Andreas Lake.
  4. Add faults A and B to the map, modifying the Special Studies Zone slightly.
  5. Do not show the air photo lineaments of Pampeyan.
9. Investigating geologist; date.

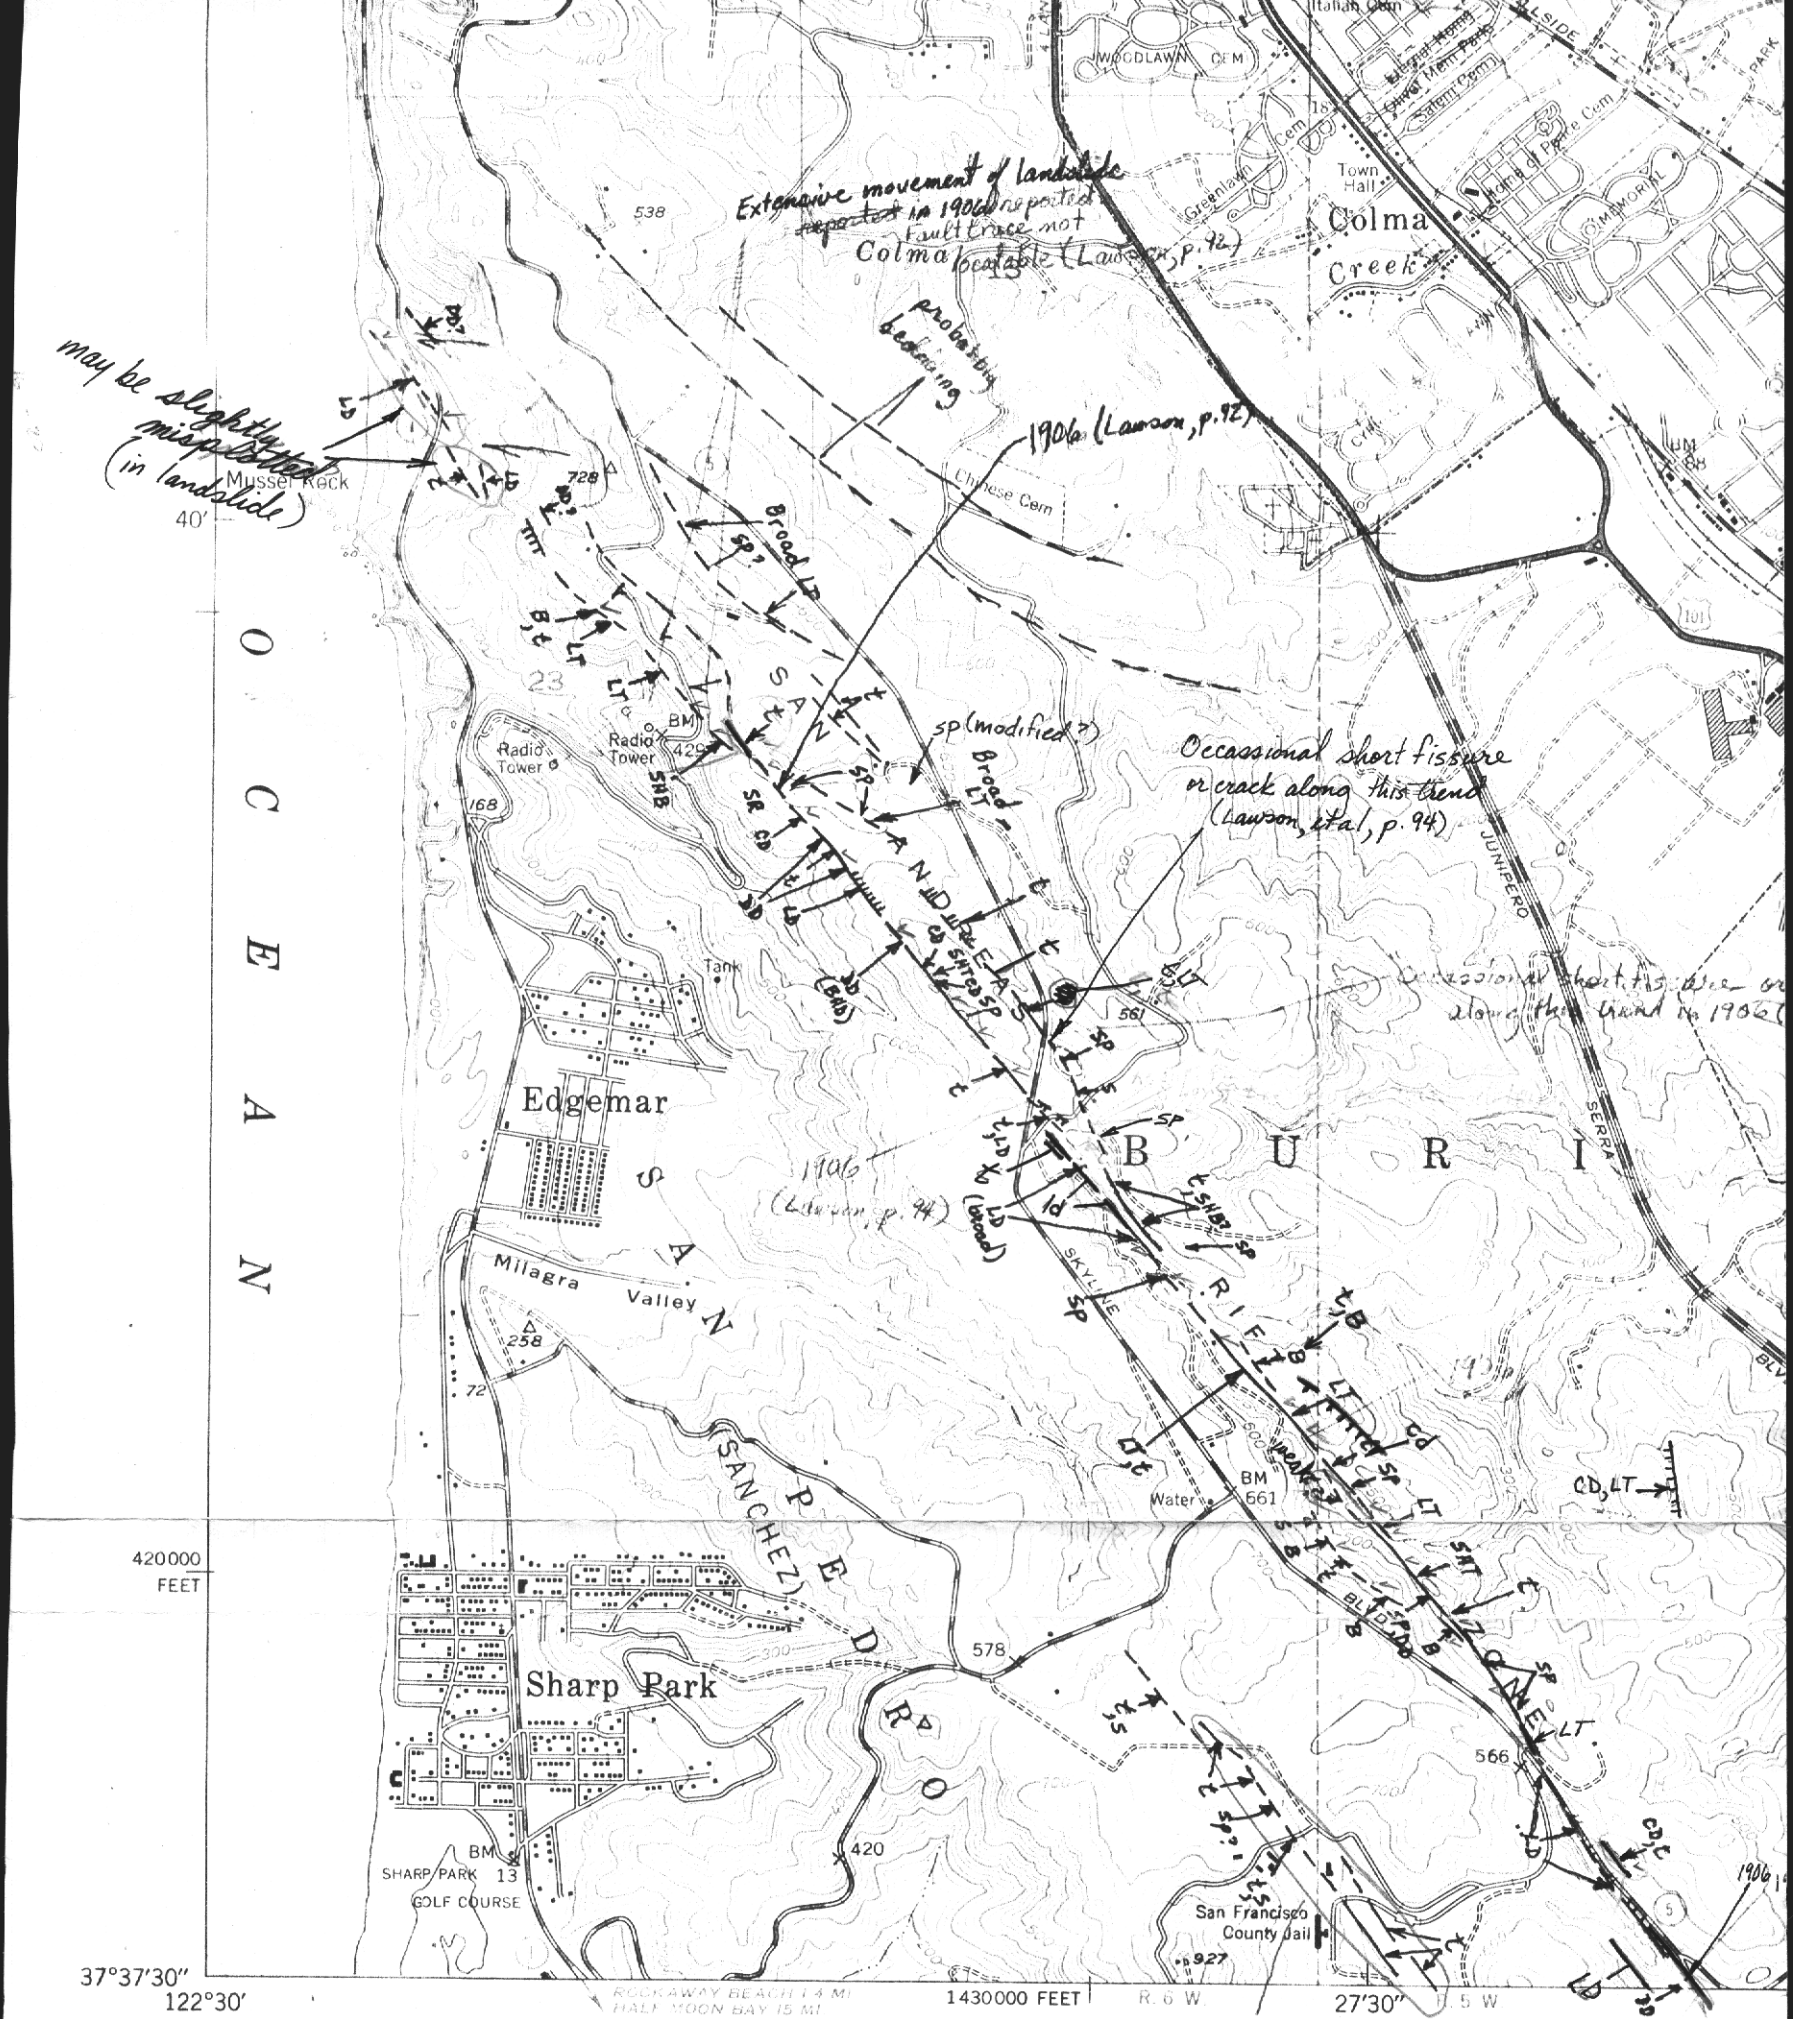
Figure 3. Air photo interpretation, with annotations from Larson, and  
others (1906).

The fault trace mapped by Pampeyan beneath San Andreas Lake could not be observed since the lake was at its highest level in 1941. The photos do clearly show two small linear sag ponds along the trace delineated on the preliminary review map (see Fig. 3B in FER-120).

Based on the detailed mapping by Hall (1981) and Pampeyan (1981a), it appears that several of the features shown on Fig. 3B of FER-120 between Lower Crystal Springs Reservoir and San Andreas Lake are artificial. Also, the main recent fault break appears to be west of that shown on the preliminary review map in the area between these two lakes. To the south, the reported pipeline offset suggests the 1906 break lies slightly west of that shown on the preliminary review map. Also, based on Pampeyan's (1975; 1981) maps, it appears there is an additional Holocene fault beneath part of San Andreas Lake south of John Muir School.
